Inspection Report

Quality Inspection Services

Property Address

1234 Anywhere, KS 67204

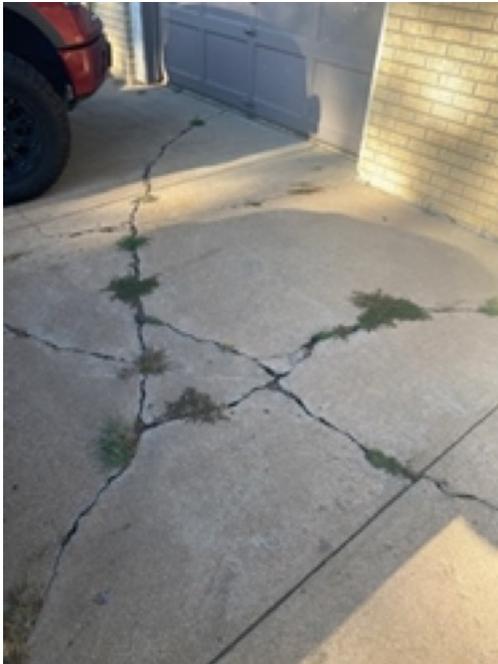
1.2) Driveway Conditions R

Major cracks were found in the driveway. The driveway appears to be approaching the end of its useful life.

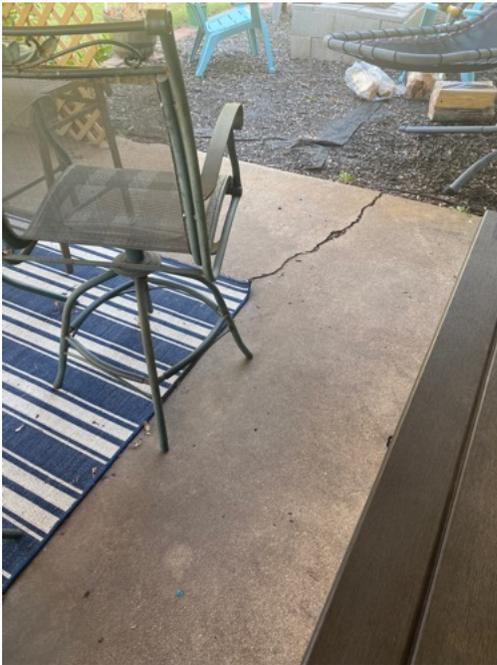
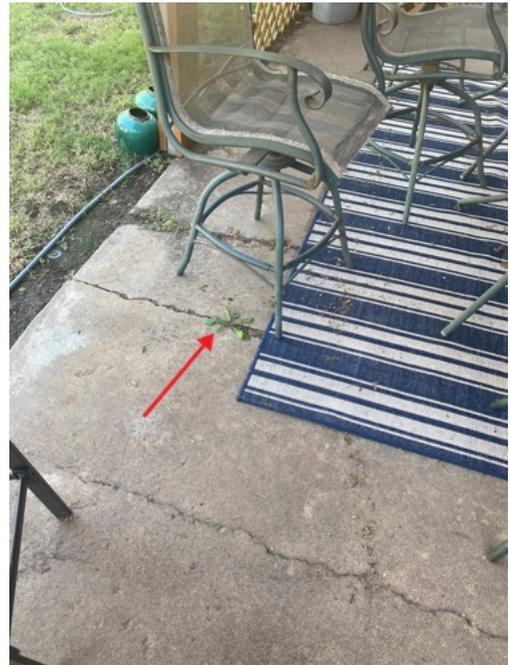
2.2) Back Entrance Conditions

Substantial cracks and / or settlement were observed in the patio.

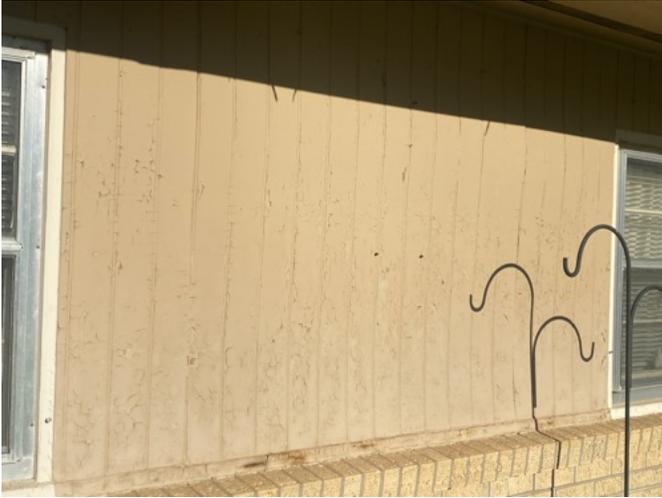
2.3) Exterior Wall Conditions

The paint / finish of the siding was deteriorated and is in need of repair, replacement and / or maintenance.

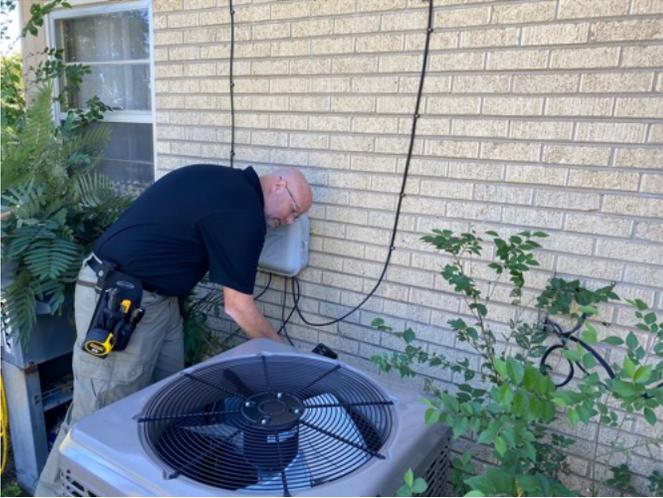
4.5) AC Unit Conditions AS

Airflow surrounding the condenser appears to be limited. Suggest removal of excess vegetation within two feet from the condenser.
